ALASKA DEPARTMENT OF ENVIRONMENTAL CONSERVATION

SITUATION REPORT

INCIDENT NAME: Pile Bay Road Tanker Trailer Spill **SITREP** #: 17

SPILL NUMBER: 09269915701 **LEDGER CODE**: 14274760

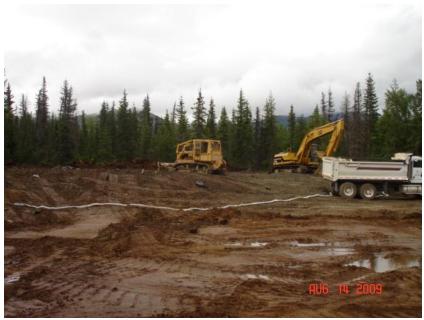
Uncompleted remediation area Pile Bay Road Spill site-ADEC

RESPONSE ACTION: Finish-work on the three former stockpile areas and the remediation site continues. IDC personnel are currently removing oversized rocks and leveling the soil at the remediation site. IDC is expected to be completed with the remediation site by mid September 2009. When the remediation site is completed ADEC and Bristol Environmental personnel will be on site for final inspection of the area.
